Manhole Inspection Summary

Manhole # S25G__007MH

Insp Date: **8/30/07 9:04 AM**

Location Address: **1121 CARLTON ST**

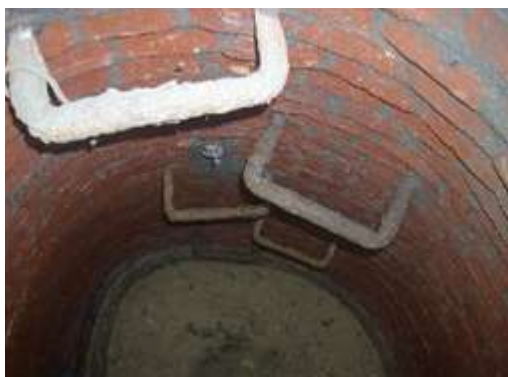
Defect 4

Steps Count: **5** Missing: **0** ☒ Corroded

CORRODED STEPS

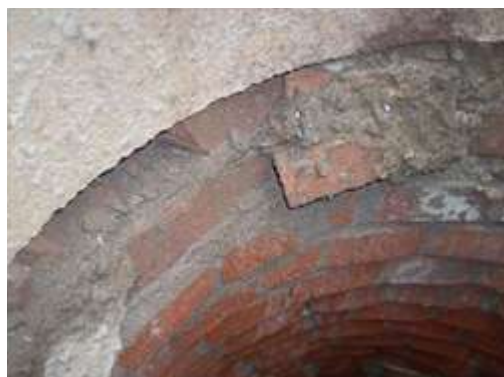
Defect 3

Chimney / Frame Adjustment ☒ Exists Material: **Brick and Concrete** ☐ Parged Height: **6** (in.)
Condition: ☐ Sound ☐ Cracked ☐ Root Intrusion ☒ Loose Brick ☒ Deteriorated
Infiltration: ☒ None ☐ Joint ☐ Cracks ☐ Mortar ☐ Roots ☐ Wall

DETERIORATED CHIMNEY WITH
LOOSE BRICKS

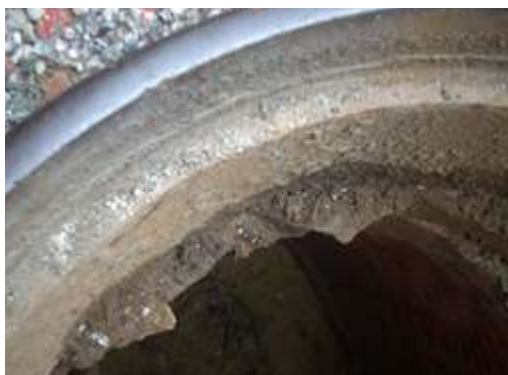
Defect 2

Frame Offset: **2** (in.) Condition: ☒ Sound ☐ Cracked ☐ Leaks

FRAME OFFSET

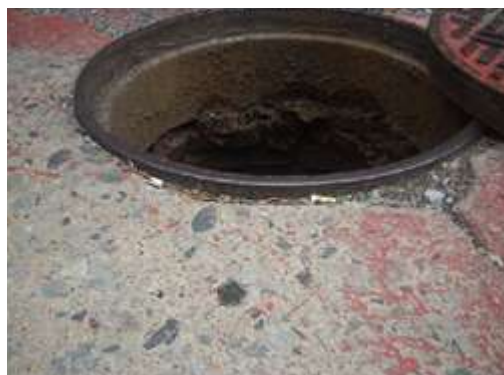
Defect 1

Cover Shape: **Circular** Diameter: **24** (in.) Length: (in.) Dist A/B Grade: **1** (in.)
Type: **Sanitary** Condition: **Sound** Cover Material: **Cast Iron**
Properties: ☐ Bolted ☐ Vented ☐ Water Tight ☐ Water Tight Insert

GRADE ADJUSTMENT

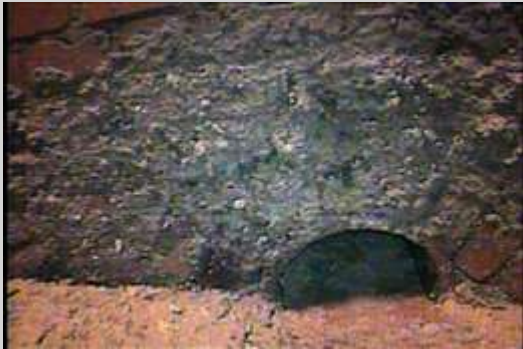
12 O'Clock Outflow

Pipe Height: **7.2** (in.) Rod and Bar (Angled)
Pipe Material: **Clay** ☐ Pipe Lined
Invert Depth: **9.05** (ft.) Flow Characteristics: **None**
Deposits: ☐ None ☒ **Mud** ☐ Sludge ☐ Debris ☐ Grease
Silt Depth: **3** (in.) Deposits Extent: **Medium**
Infiltration: **None** Pipe Seal Cond: **Sound**

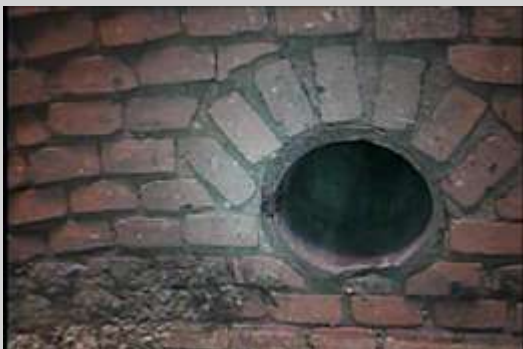
3 O'Clock Outflow

Pipe Height: **8.4** (in.) Rod and Bar (Angled)
Pipe Material: **Clay** ☐ Pipe Lined
Invert Depth: **7.41** (ft.) Flow Characteristics: **None**
Deposits: ☒ None ☐ Mud ☐ Sludge ☐ Debris ☐ Grease
Silt Depth: (in.) Deposits Extent:
Infiltration: **None** Pipe Seal Cond: **Broken**
